## The Curia Julia: Its History, Materials, Use, and Preservation through the Centuries

THE CURIA JULIA  
ITS HISTORY, MATERIALS, USE, AND PRESERVATION  
THROUGH THE CENTURIES

FOR DEPARTMENTAL HONORS IN CLASSICS

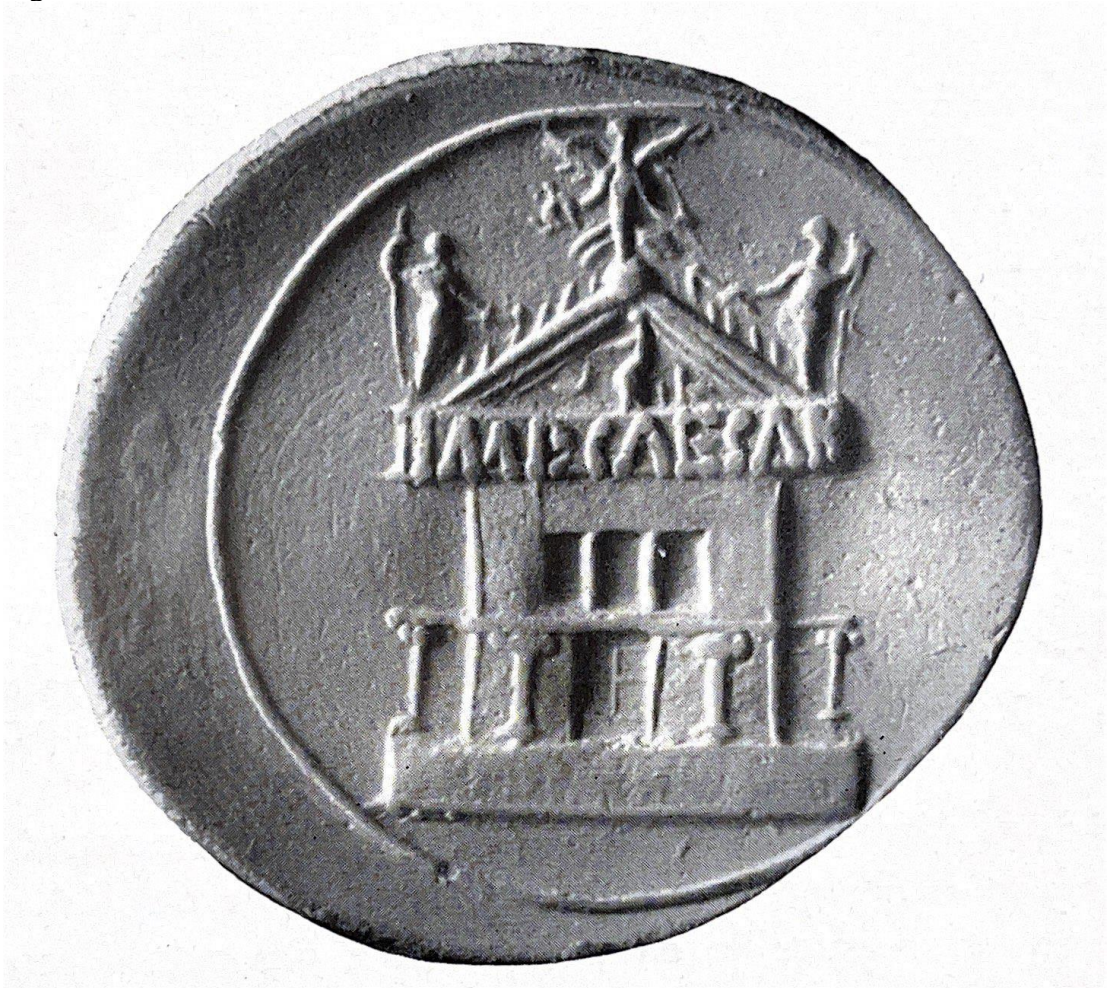
Figure 2:

A coin of Augustus (fig. 2) from around 29-27 BCE is a showcase of how the Curia looked back in antiquity. Even though this is an artifact and not a written document, this coin still acts as a document for the history of the Curia Julia because it shows what the Curia looked like when it was first built. The coin is a silver denarius with a portrait of Octavian on the obverse, and an image of the Curia Julia on the reverse. The reverse shows only the front façade, but it includes a number of clues as to its details. There is a colonnaded porch around the door, as well as

decorations on the gable and a statue representing Victory on a globe in the center. There are two other statues on either side of the Victory statue, both of which are warriors holding staffs.<sup>2</sup>

appearance affirms Ioppolo's drawing in that it is consistent with his interpretation of the structure. However, the coin also depicts the Curia as having a crowned gable along with a statue of Victory on top of the roof.

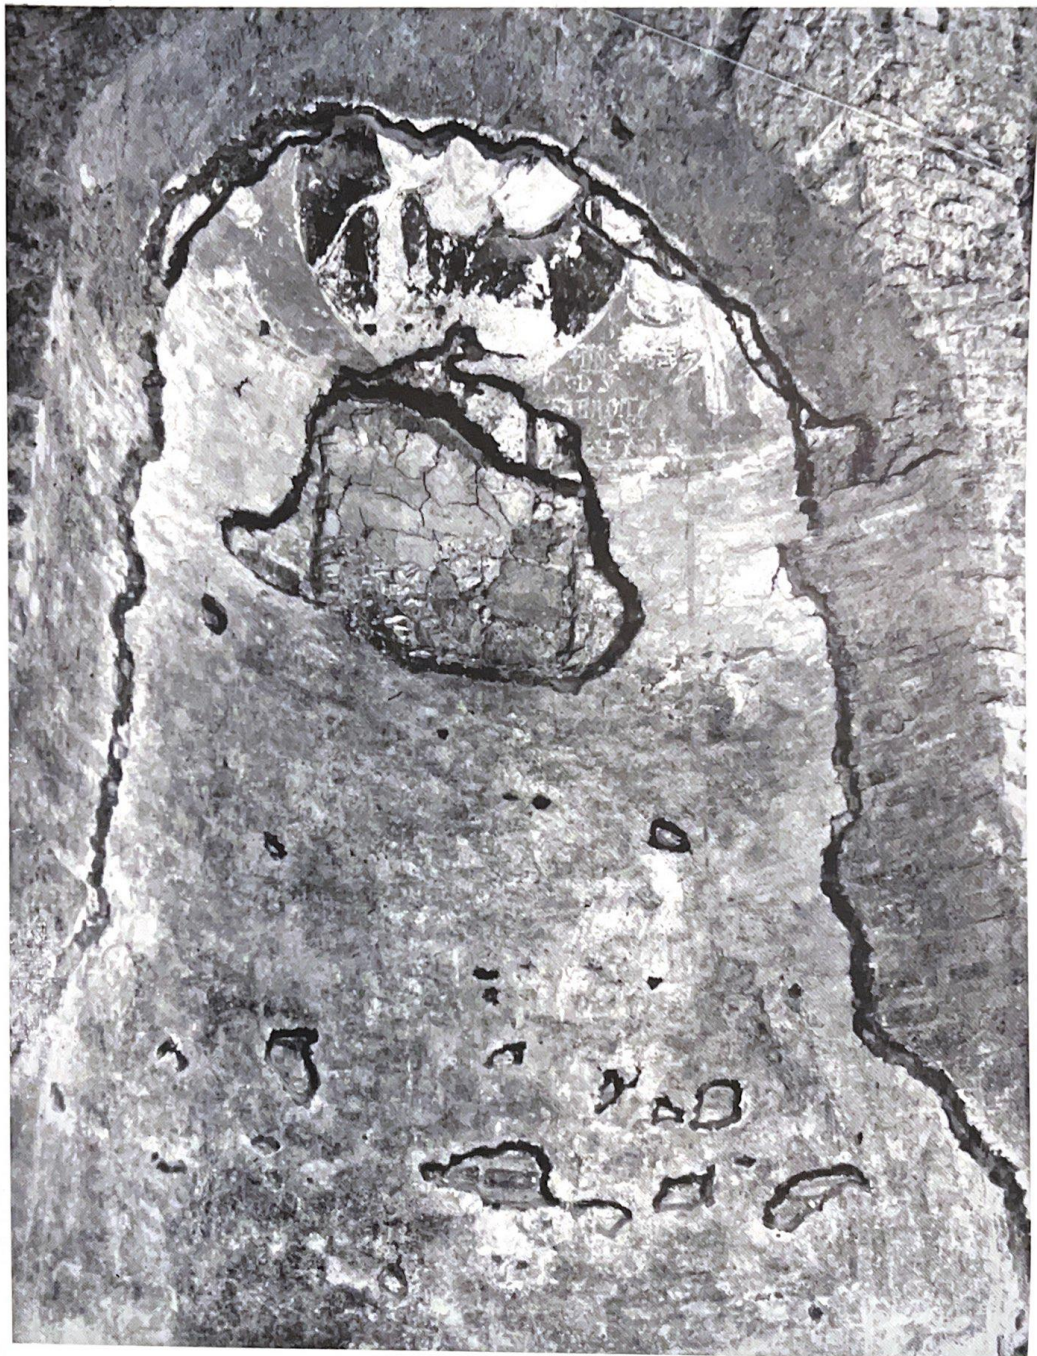
Figure 3: Medieval-era wall painting. Bartoli, *Curia Senatus: lo Scavo e il Restauro*, Tav. 70

Fig. 1 - S. Adriano: interno. Pitture entro la nicchia centrale della parete sinistra.

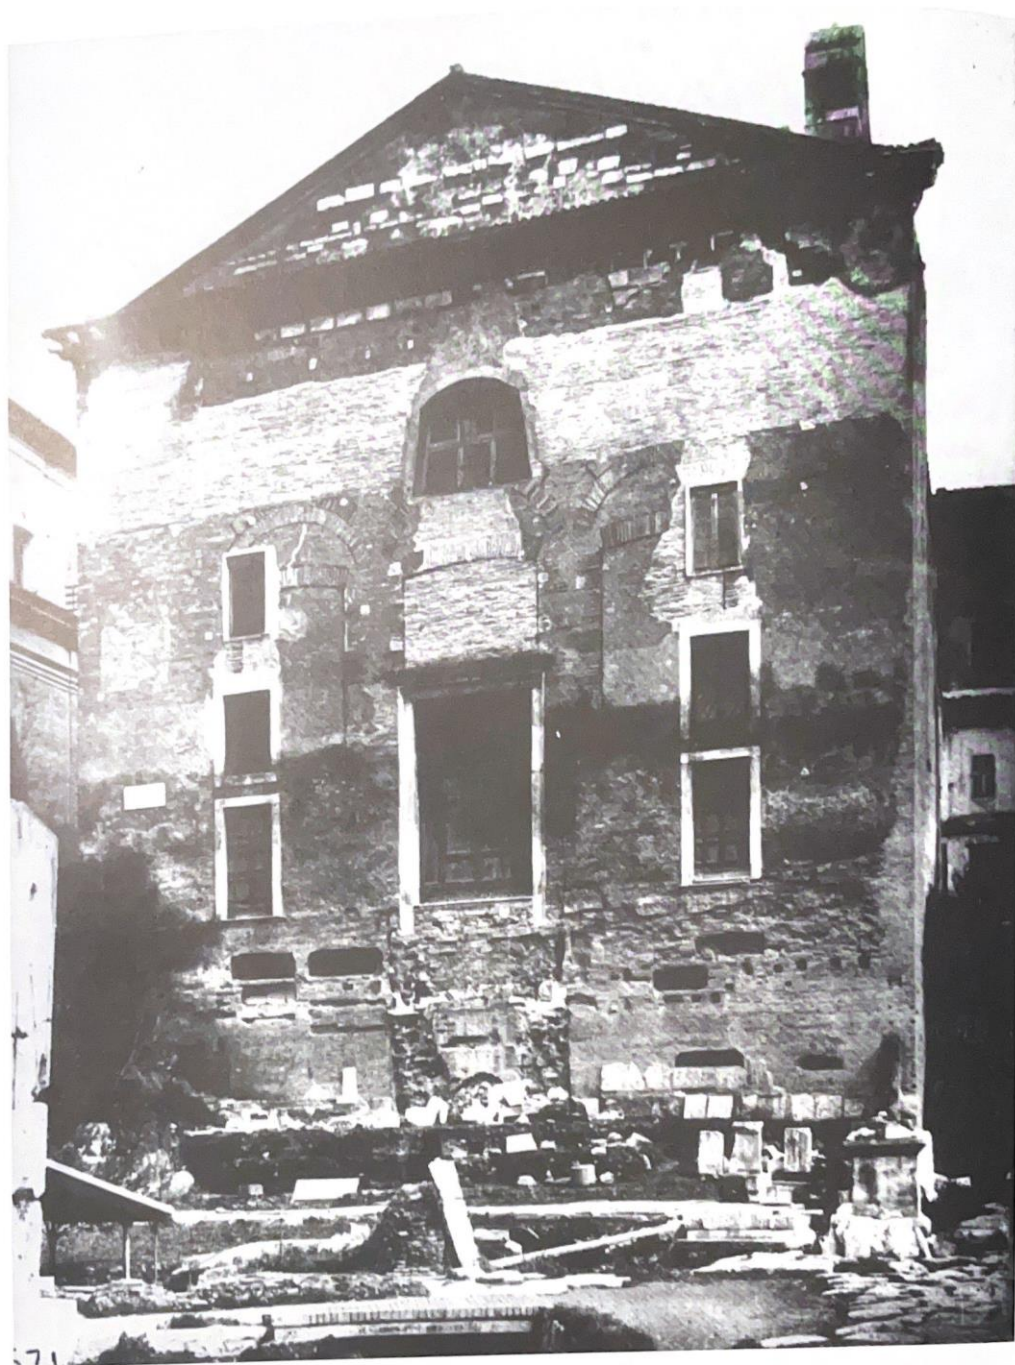
Figure 5:

After Boni's isolation of the Curia's façade, it appeared similar to the façade of the medieval period before it was transformed into a Baroque style church. The photograph (fig. 5) and Giovannoli's print (fig. 4) show striking similarities in the Curia's appearance. After Boni, the Curia's façade was a mixture of different materials from different time periods. On the tympanum and below the cornice were rectangular pieces of ashlar masonry, while the rest of the façade was made of varying shades of bricks. The relieving arches that once made up the windows of the ancient Curia were visible, but the five modern windows cut through them at different places. The four smaller modern windows were rectangular, stacked vertically on the façade, and were located on either side of the door. The larger modern window was located above the door, in a semicircle shape not dissimilar to the top of a Palladian window that would be seen in later architectural styles. Additionally, there were two other smaller doors that were located on either side of the main door, both of which were parallel to the two modern windows above them. Overall, the most prominent

thing about the results of Boni's isolation is the visibility of the different materials that made up the Curia's façade and how the varying shades of bricks showcased the changes that the building went through.

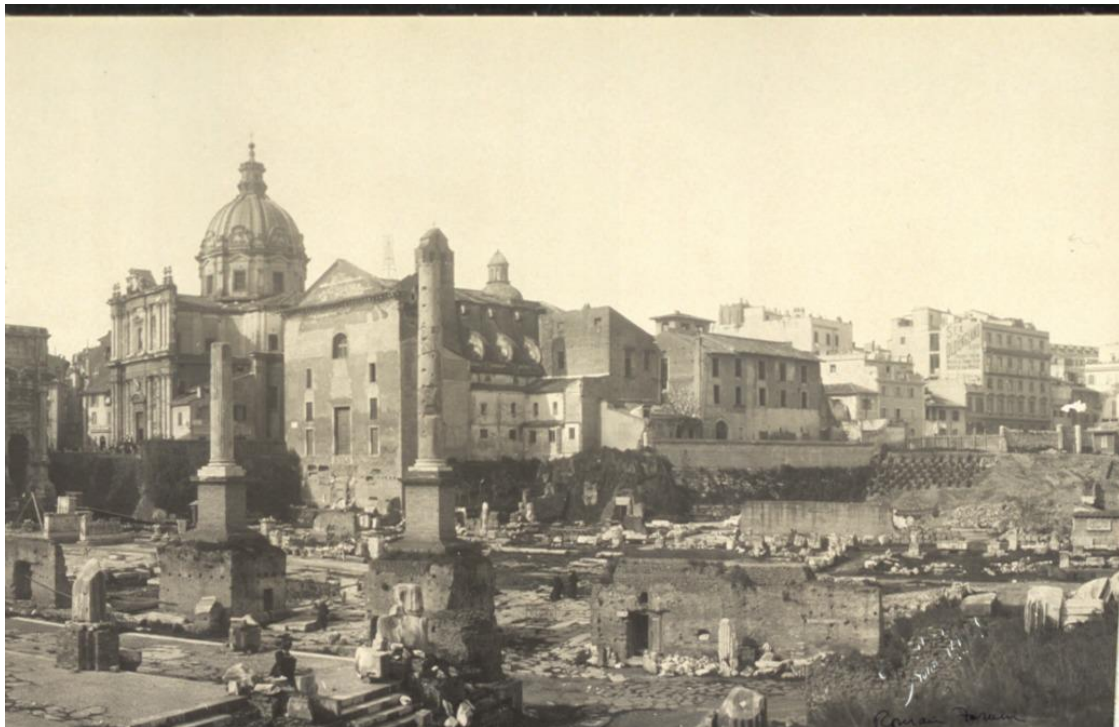
Figure 6: Photograph taken of entire Curia in 1909. Wikimedia Commons, [https://commons.wikimedia.org/wiki/File:Panoramic\\_view\\_of\\_Roman\\_Forum\\_looking\\_towards\\_Capital\\_LCCN2007663209\\_part2.tif](https://commons.wikimedia.org/wiki/File:Panoramic_view_of_Roman_Forum_looking_towards_Capital_LCCN2007663209_part2.tif)

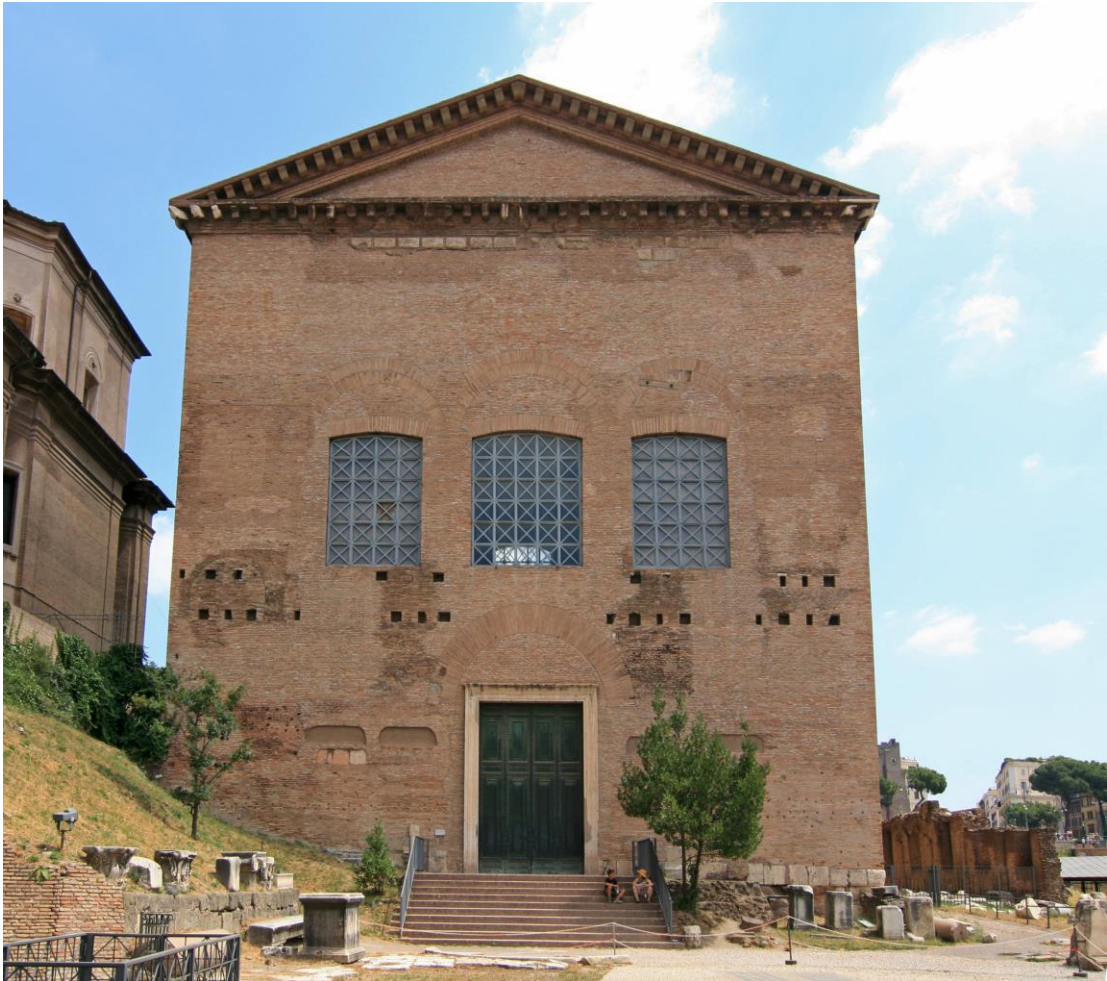
Figure 8: Picture of the Curia Julia today. Wikimedia Commons, [https://commons.wikimedia.org/wiki/File:Curia\\_Julia\\_front.jpg](https://commons.wikimedia.org/wiki/File:Curia_Julia_front.jpg)

What is most fascinating about the appearance of the Curia Julia today is the physical reminders of its various appearances throughout history. Its story can be read simply by looking at it because of the obvious differences in color between the ancient bricks and modern ones, along with the brick arches that are inlaid in the walls. A comparison between a photograph of the Curia's façade directly after Boni's excavations (fig. 5) and a photograph of the Curia today after Bartoli's restoration (fig. 8) clearly shows this history.
